Experience with Field Emission at TRIUMF (ISAC-II)

Zhongyuan Yao

WG2: Field Emission and Its Root Causes

TTC, Daejeon, Apr. 8-11, 2025

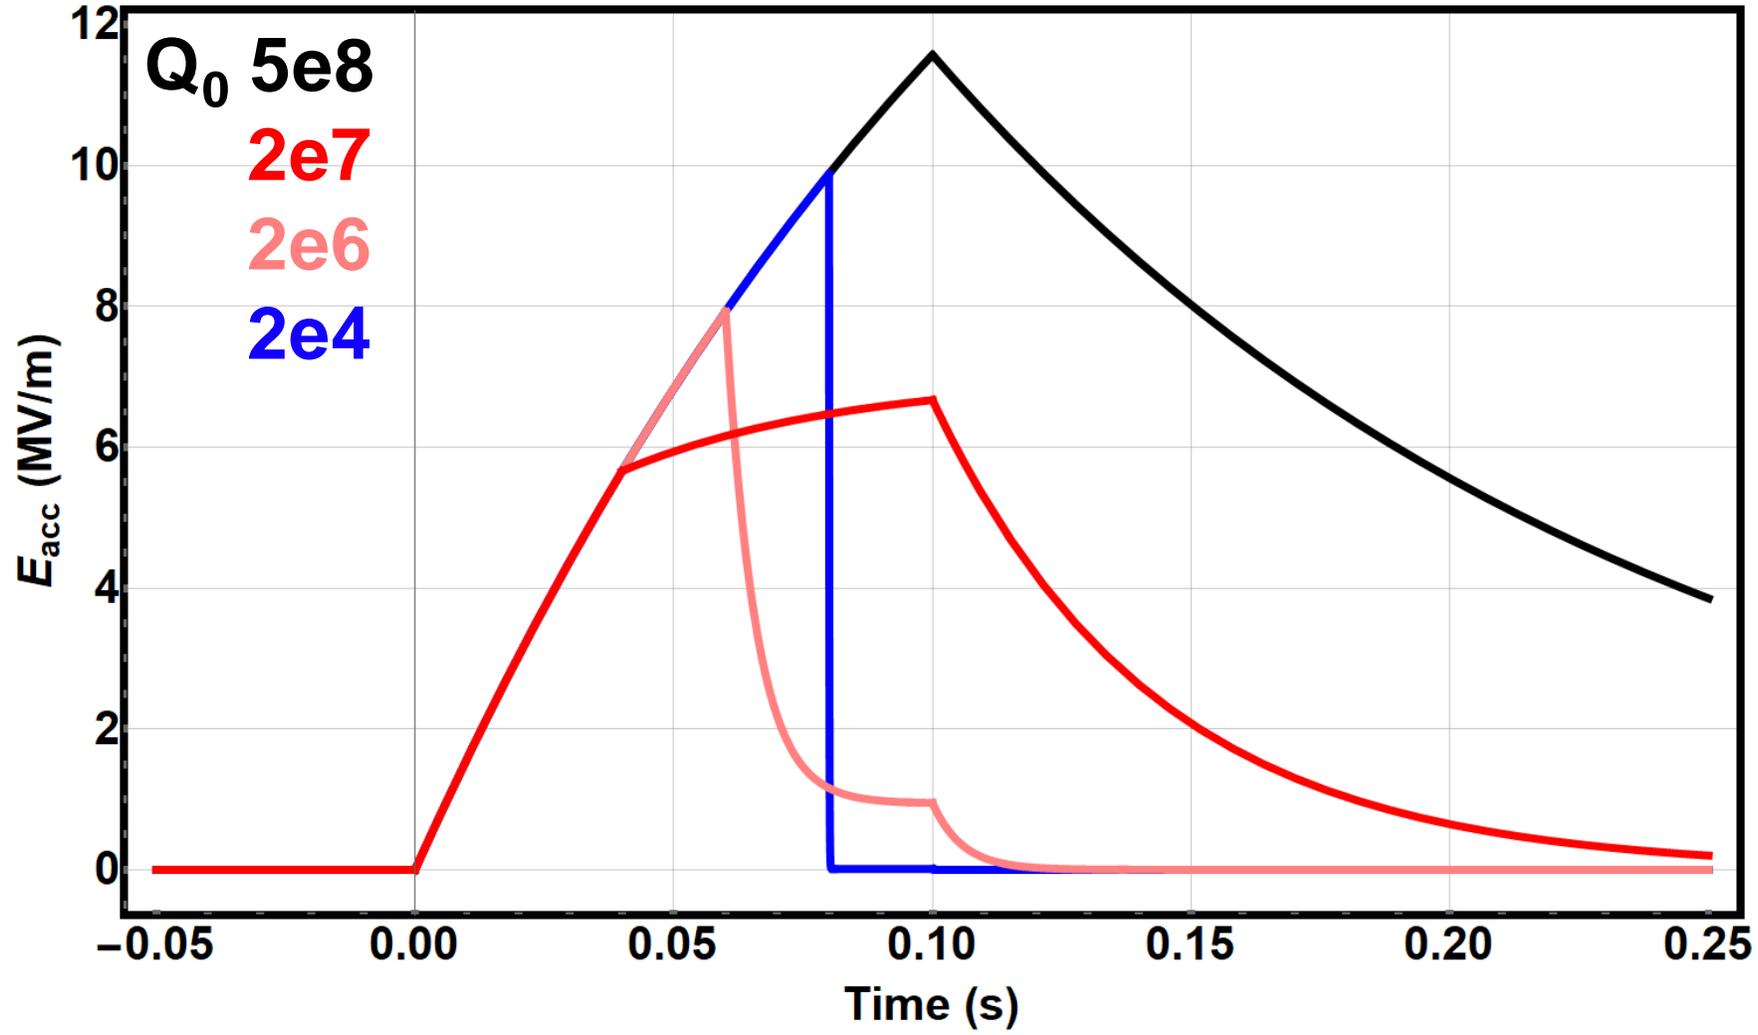
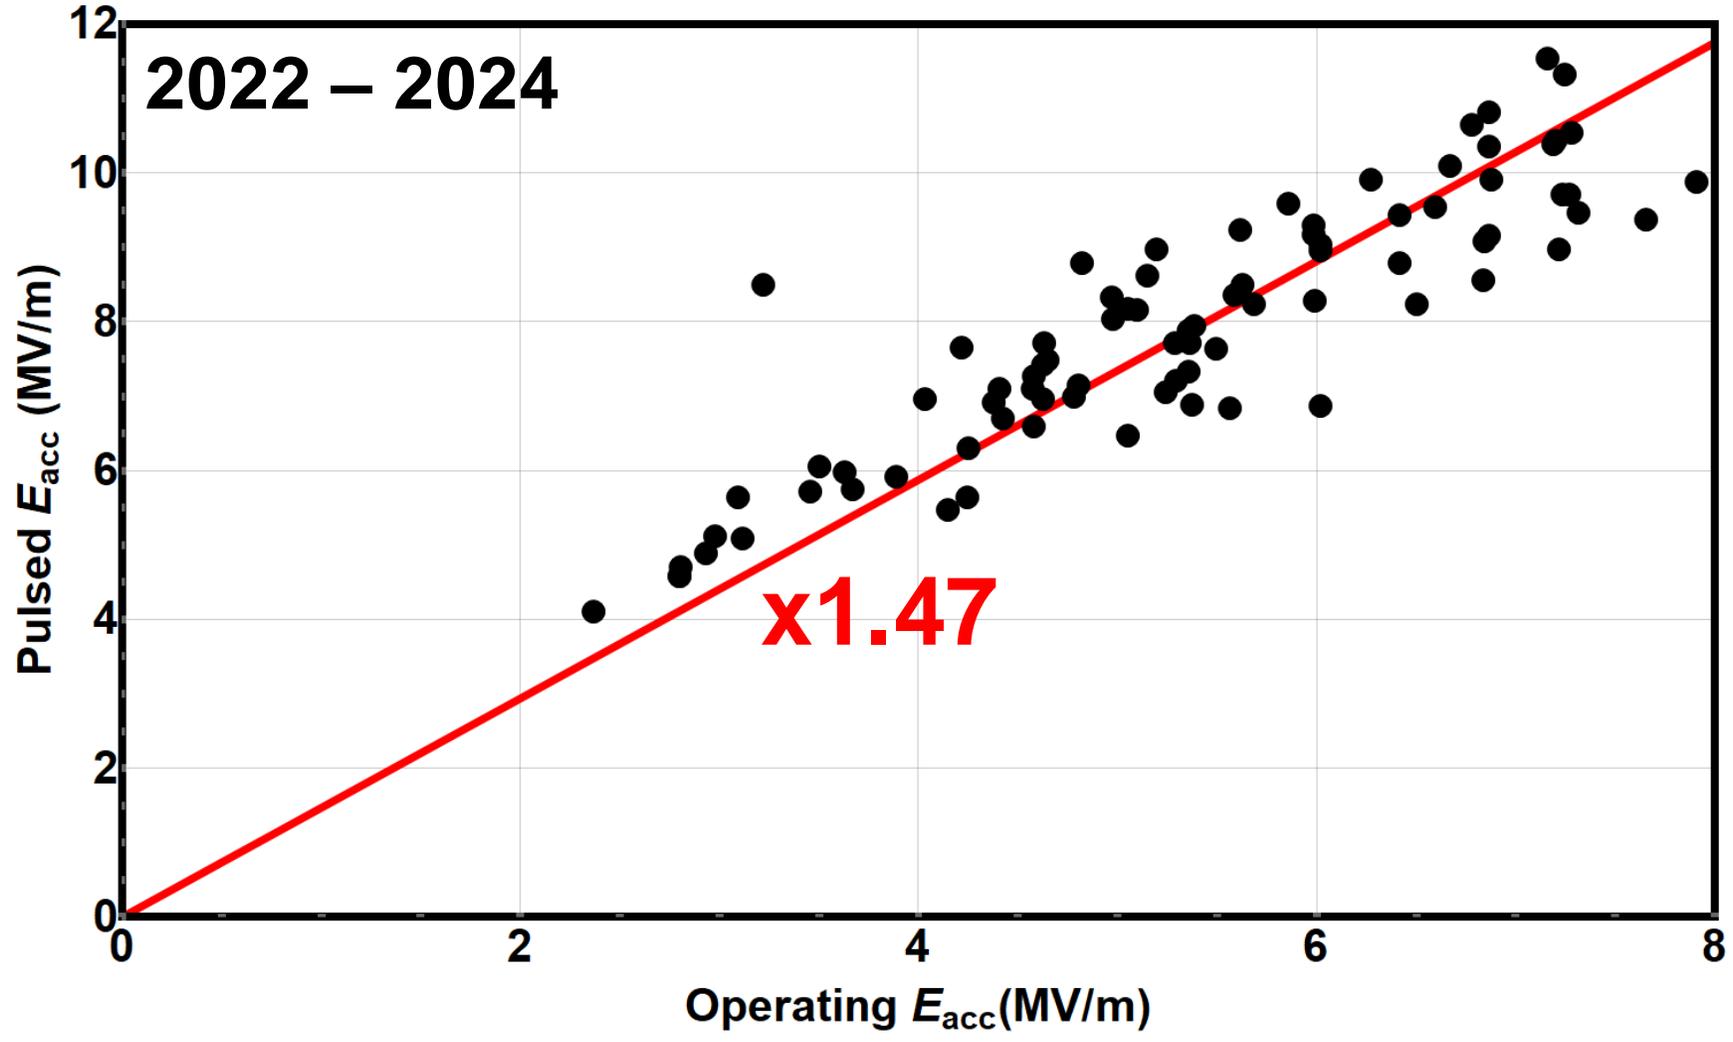
After pulse cond.
Before pulse cond.

- 40~100ms pulse length, 1Hz repetition rate, up to 200W P_{FWD}
- Variable coupler, slightly over coupling $\beta \sim 10$, normal cavity decay $\sim 200\text{ms}$
- Pulse to 50% higher field than the operating field
- Pursue 'electronic' quench to break through FE barriers

- Improvement in minutes w/ 'electronic' quench, while requires hours to days w/ 'thermal' quench or even no changes
- Effective to restore ISAC-II cavity performance

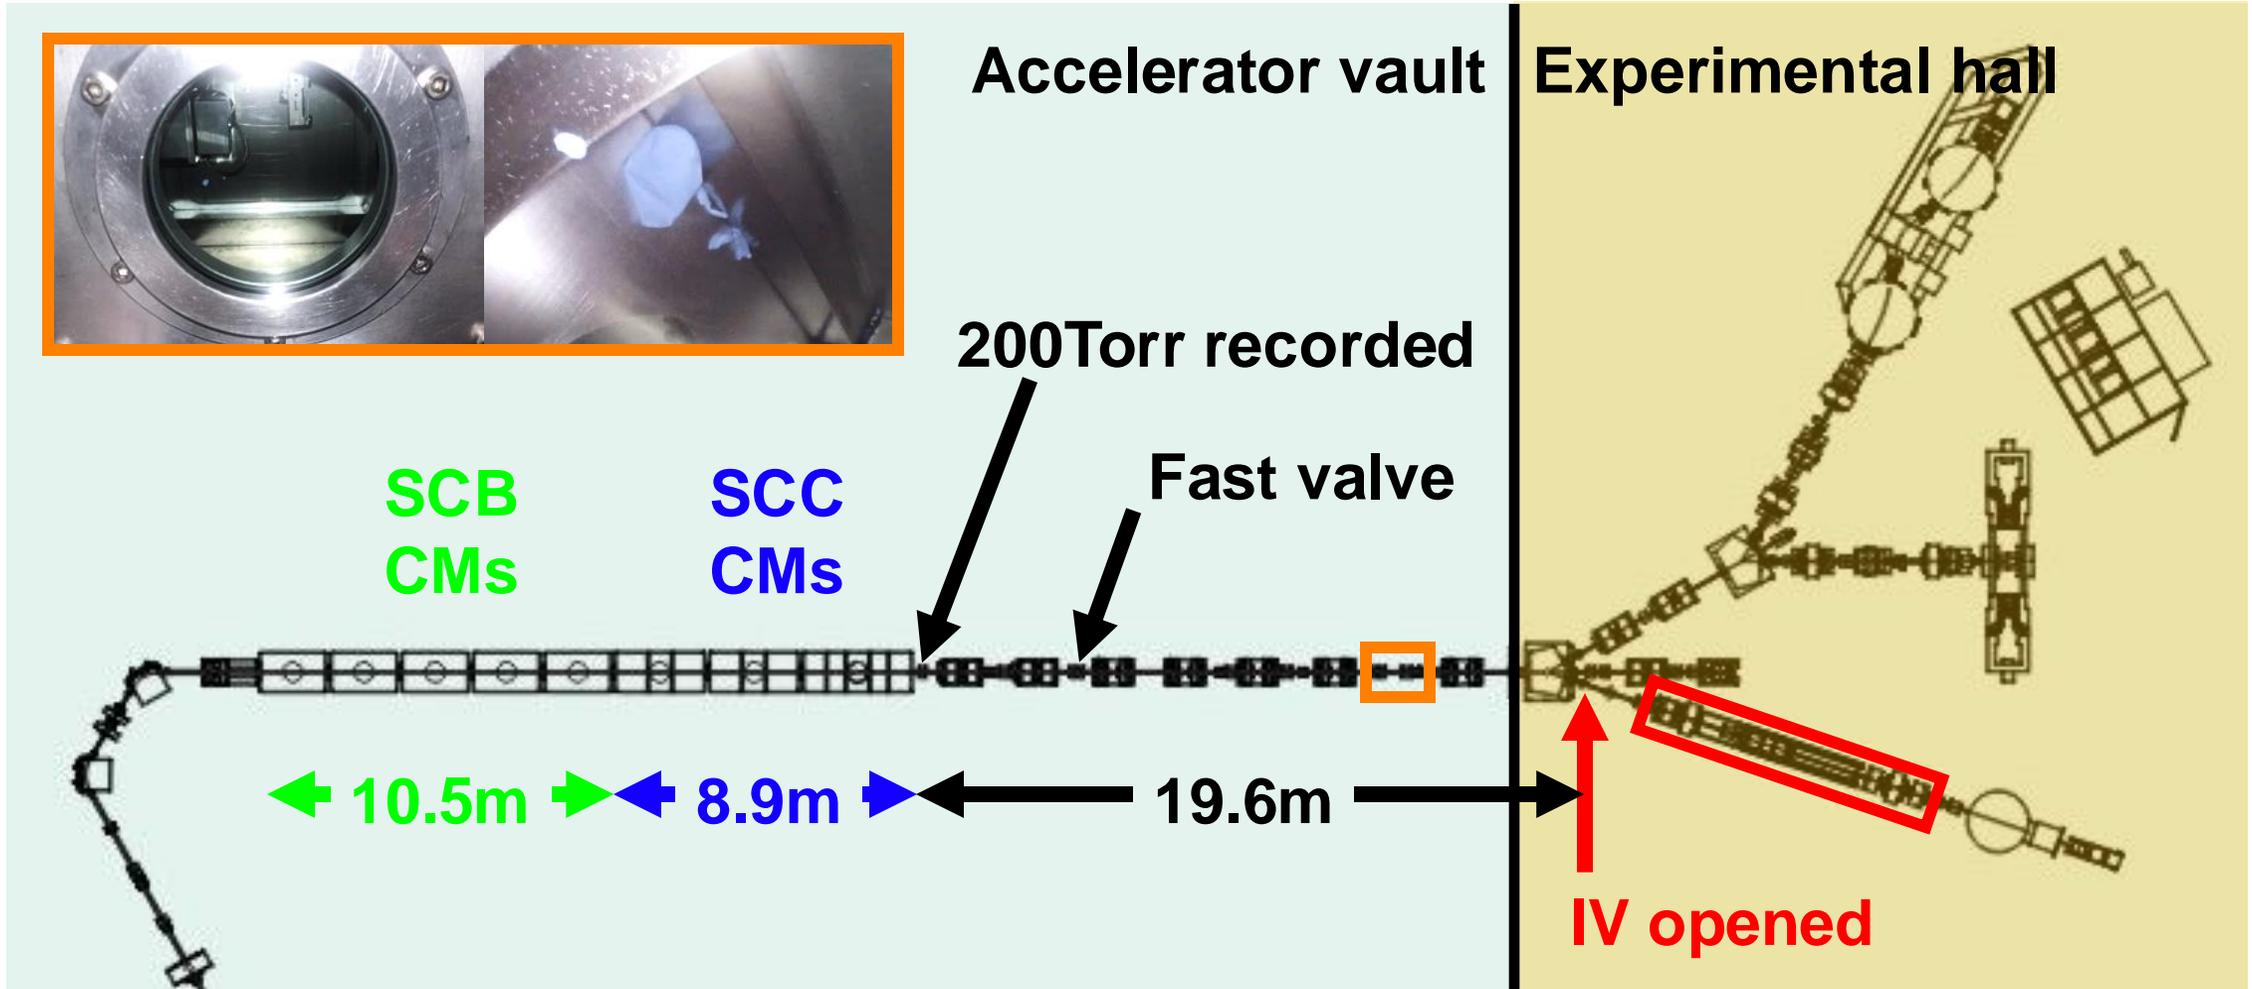
- Affected range is 8.9m, includes downstream 3 CMs
- HPR required, 2 completed and performance restored

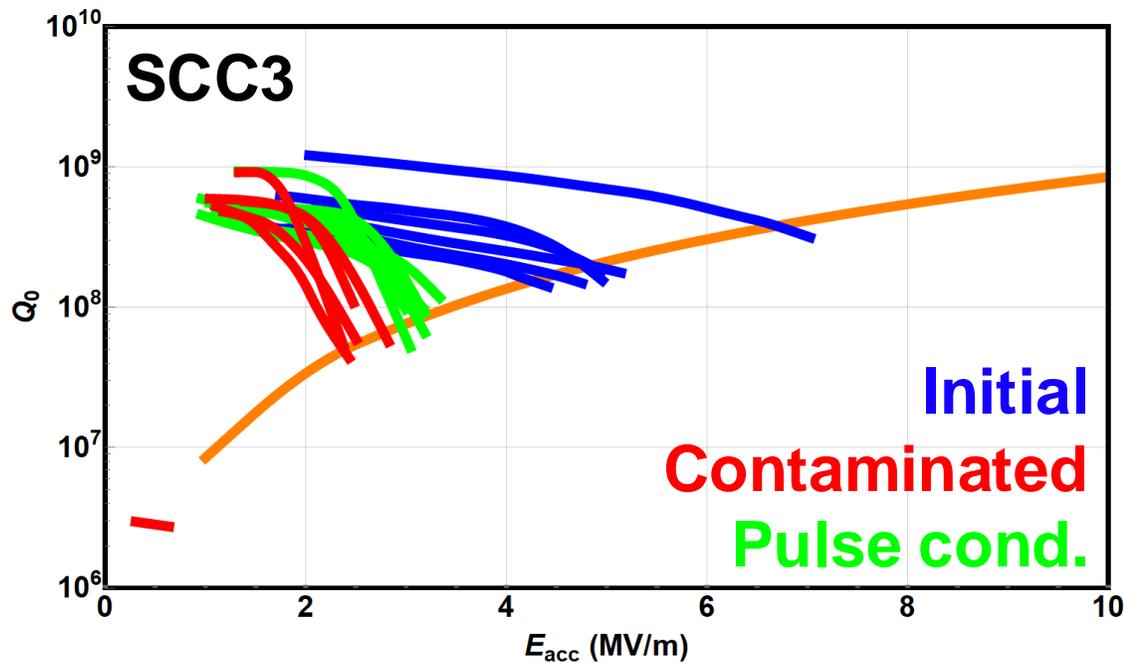
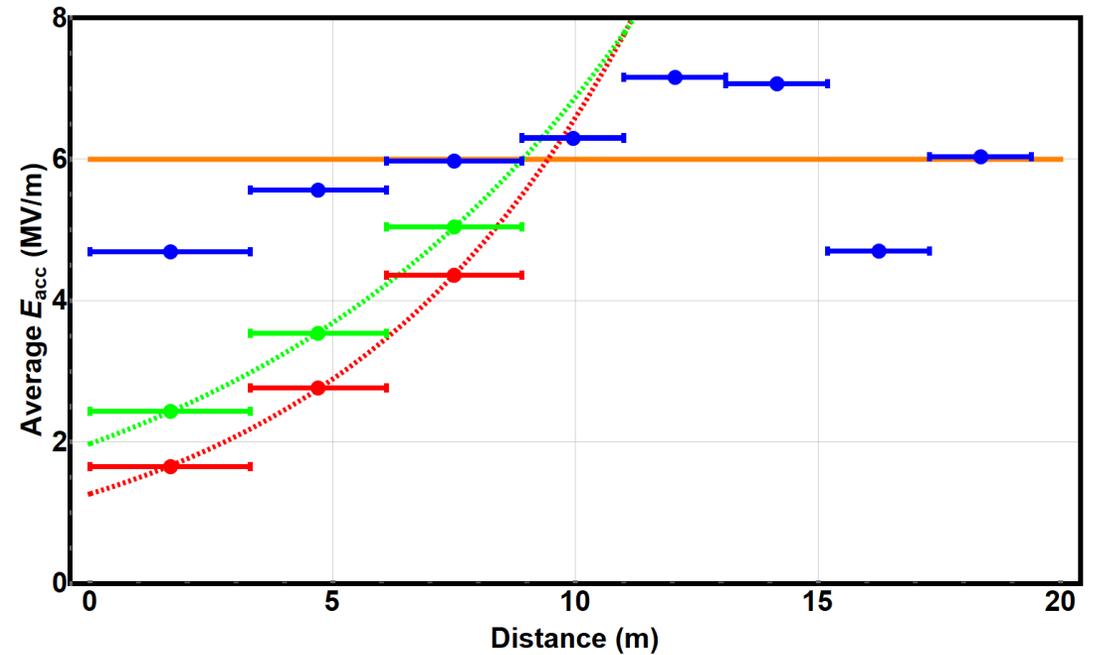
- SCC3#1 degraded after thermal cycle in shutdown
- Neighbors #2 restored after pulse conditioning
- May related to actuation of isolation valves
