Experience with field emission at RIKEN

RIKEN Nishina Center
OZEKI, Kazutaka

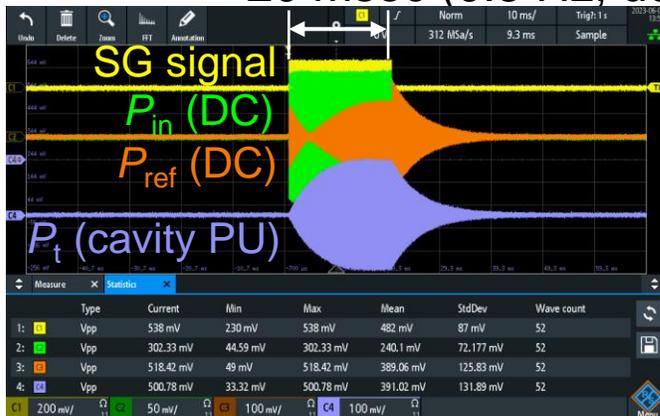
Pulsed RF power is fed into cavity
 20 msec (0.5 Hz, duty 1%)

- Peak surface field at nominal operation gradient
 → $E_{\text{acc}} = 3\text{-}4 \text{ MV/m}$ (operation voltages are set below the on-set gap voltage)
 $E_{\text{peak}}/E_{\text{acc}} = 6.2$
- Administrative/operational radiation limits (How were limits decided?)
 → [High-RF power processing \(HPP\)](#) is conducted when radiation exceeds $\sim 100 \mu\text{Sv/h}$.

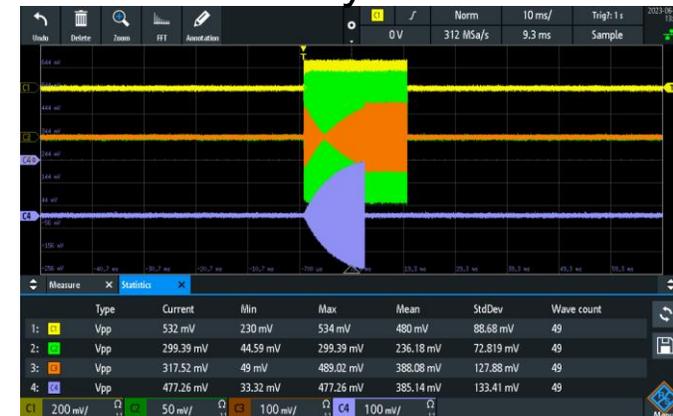
Occasional discharge
 → burn off FE sources on cavity surface

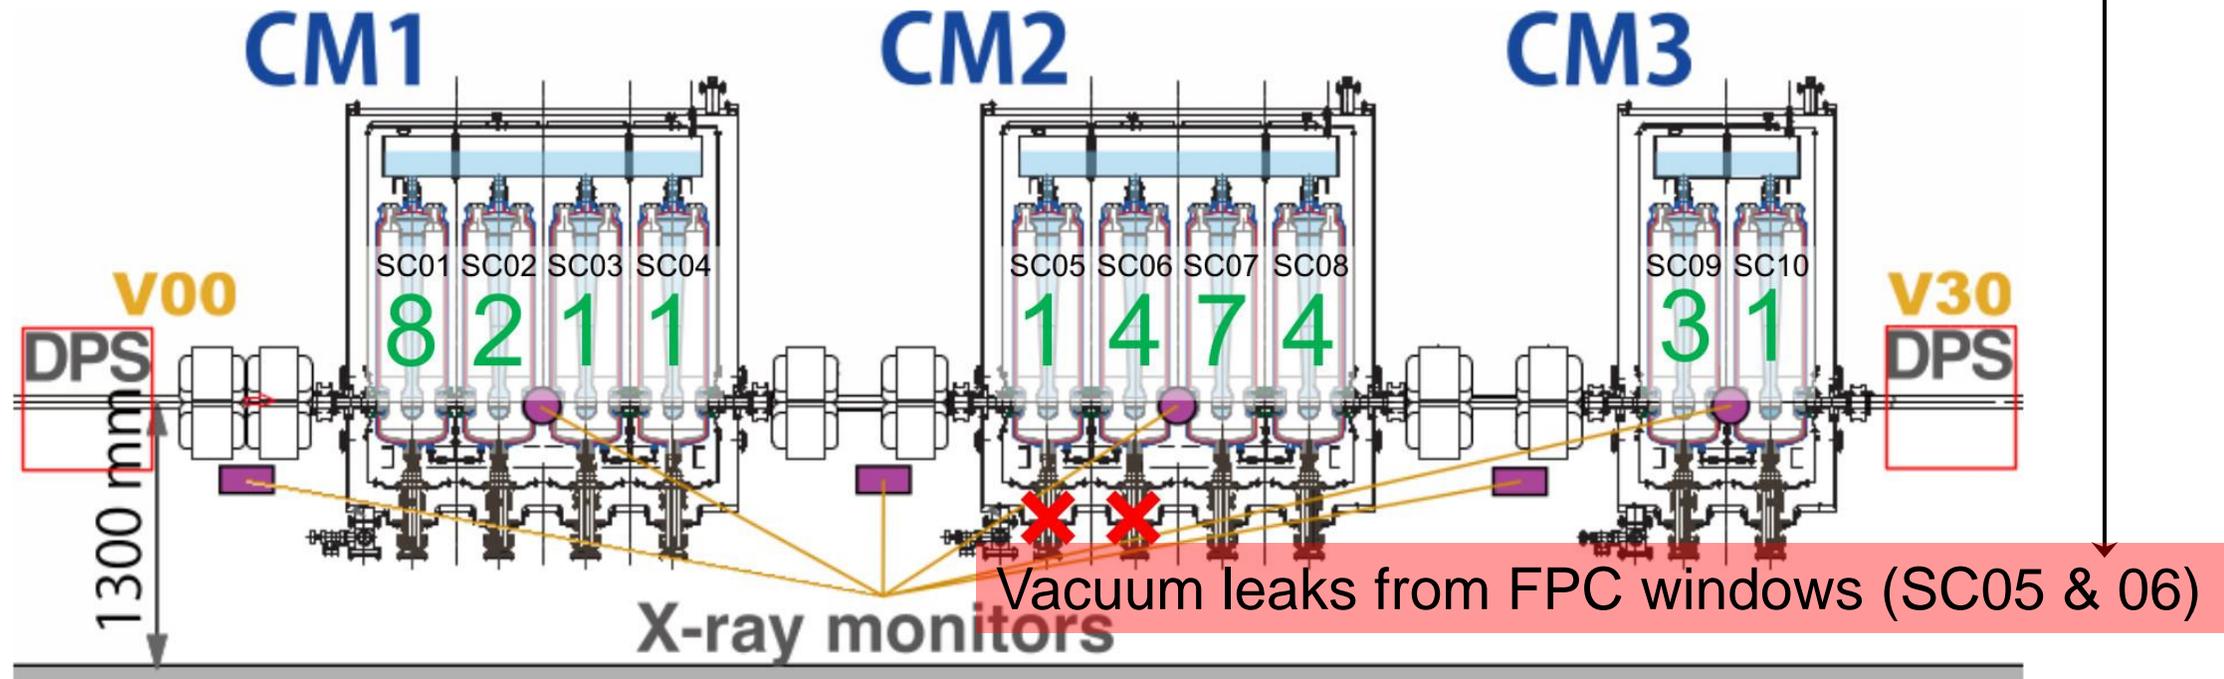
Number of times HPP conducted for each cavity

- How has field emission in the machine changed over time (**location** and magnitude)?
- Are there any **spatial patterns** observed?
- Are there **known reasons or events** this can be correlated with?

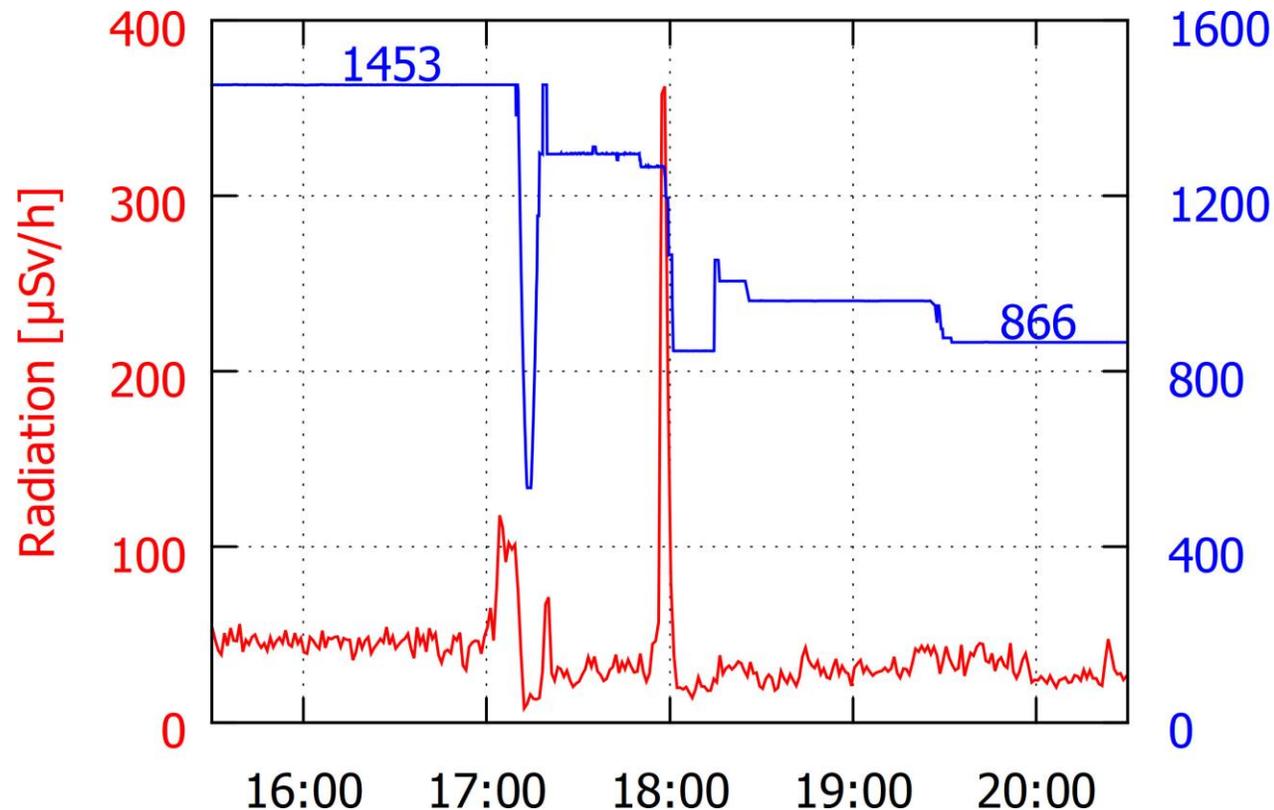
- How much performance has been lost due to the increase in field emission?
→ Actual case of SC02 on Jun 21, 2022
(HPP method had not been established yet...1st HPP: Nov 22, 2022)

Operation with $V_g = 1453$ kV
↓
FE increased twice in a short time
↓
 V_g was reduced to 866 kV
to keep moderate radiation level

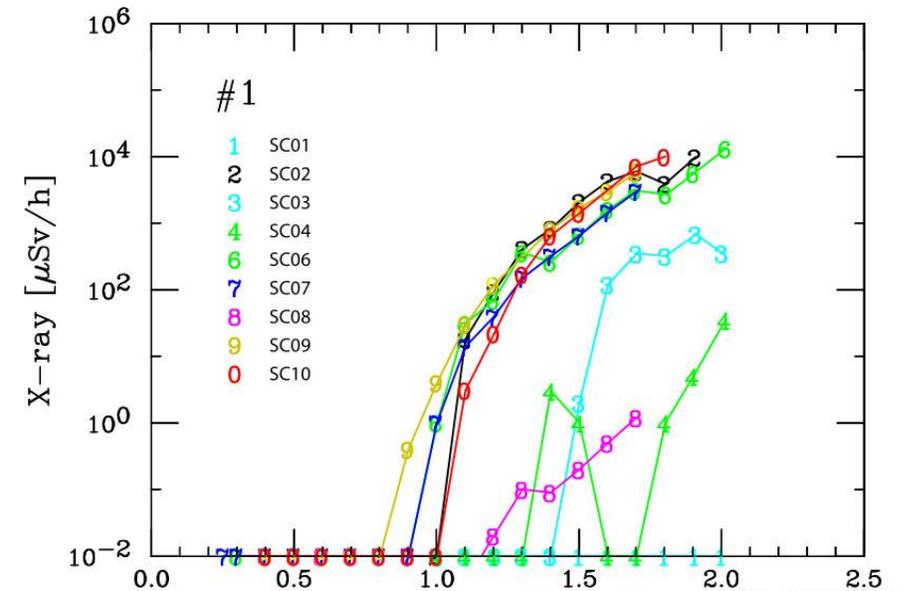
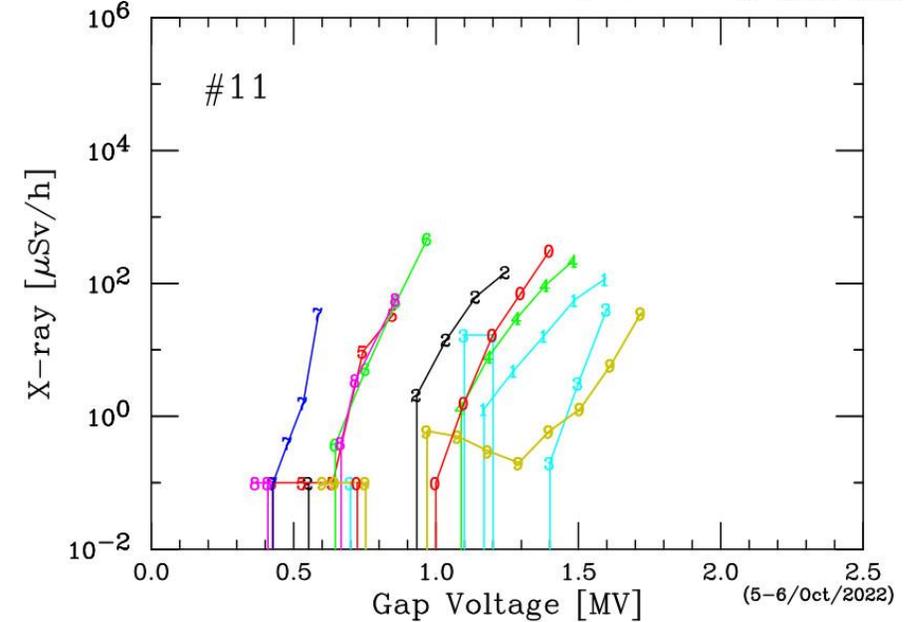
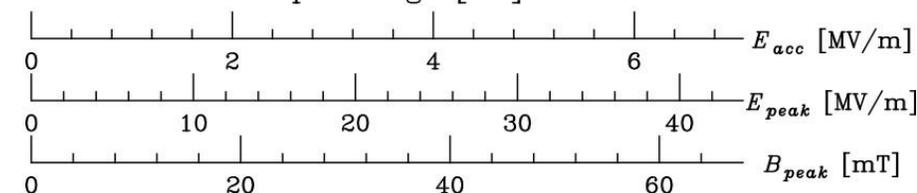
- How much performance has been lost due to the increase in field emission?
(same question with previous page)
→ Another actual case: FE measurements for each cavity (Courtesy of N. Sakamoto)

(Top) Jan 2020

- GVs of each CM had not opened yet
- CM2 had already experienced 1st vacuum leak from SC05

(Bottom) Oct 2022

- Just before 1st HPP
- Difficult to maintain total acceleration voltage

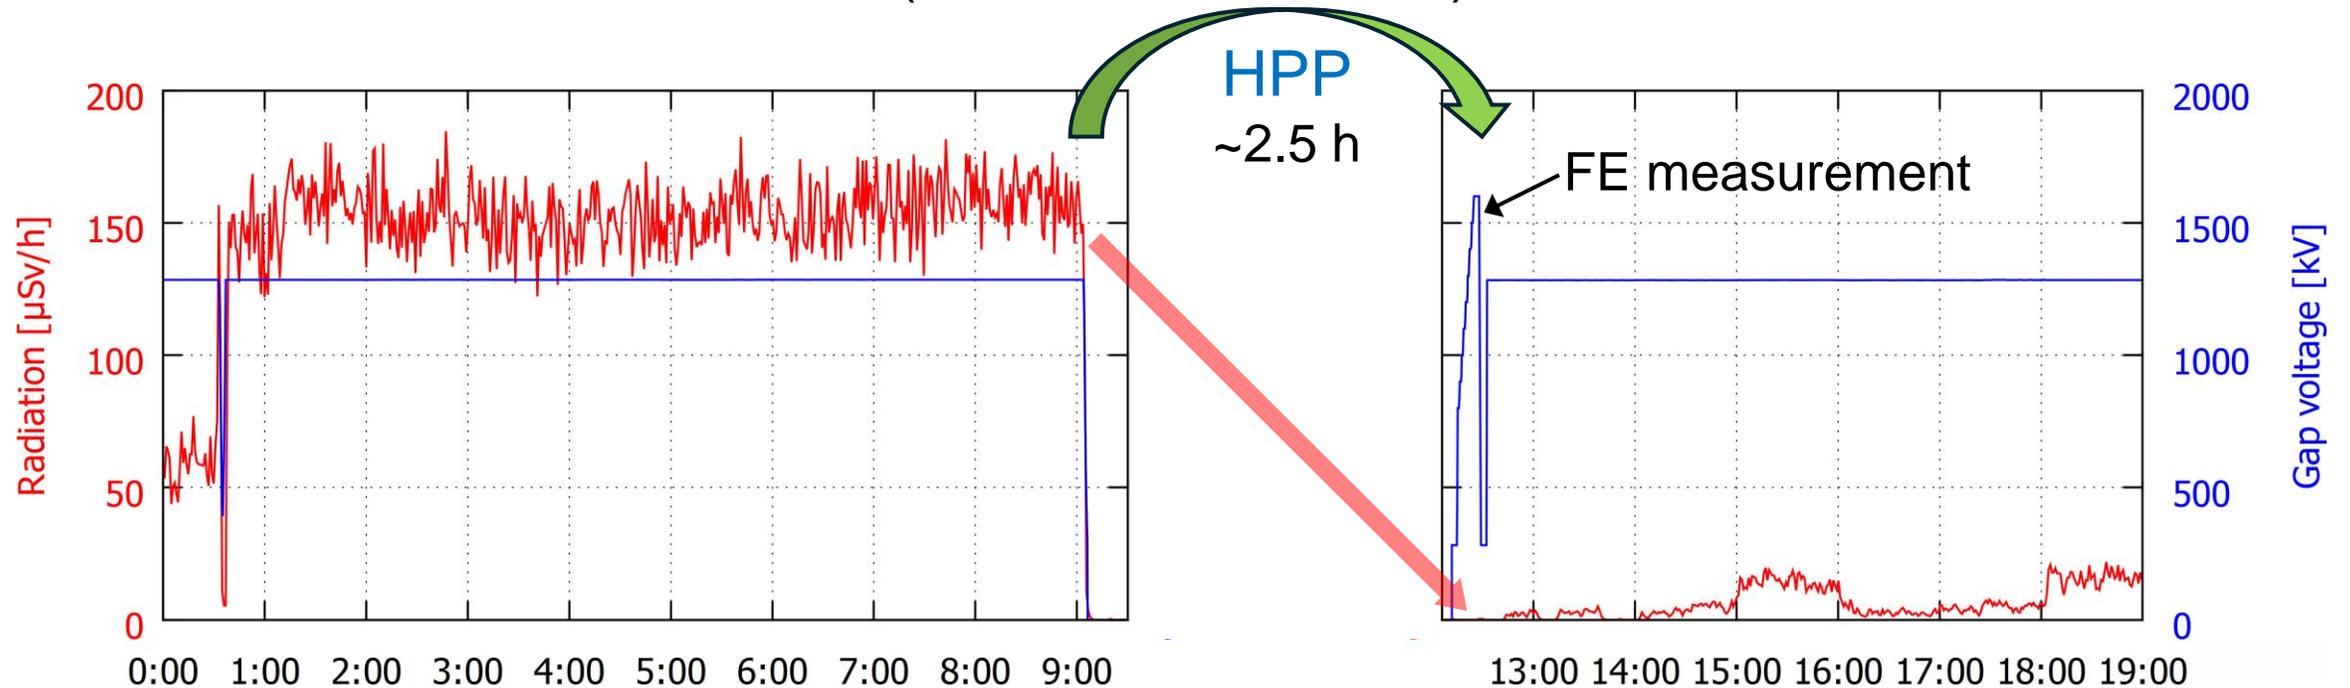
- Have there been attempts to decrease field emission in situ? → Yes
- If yes, what and to what level of success?
→ Actual case of the effect (SC01, Mar 1, 2024)
