Experience with Field Emission at TRIUMF (ISAC-II)

Zhongyuan Yao

WG2: Field Emission and Its Root Causes

TTC, Daejeon, Apr. 8-11, 2025

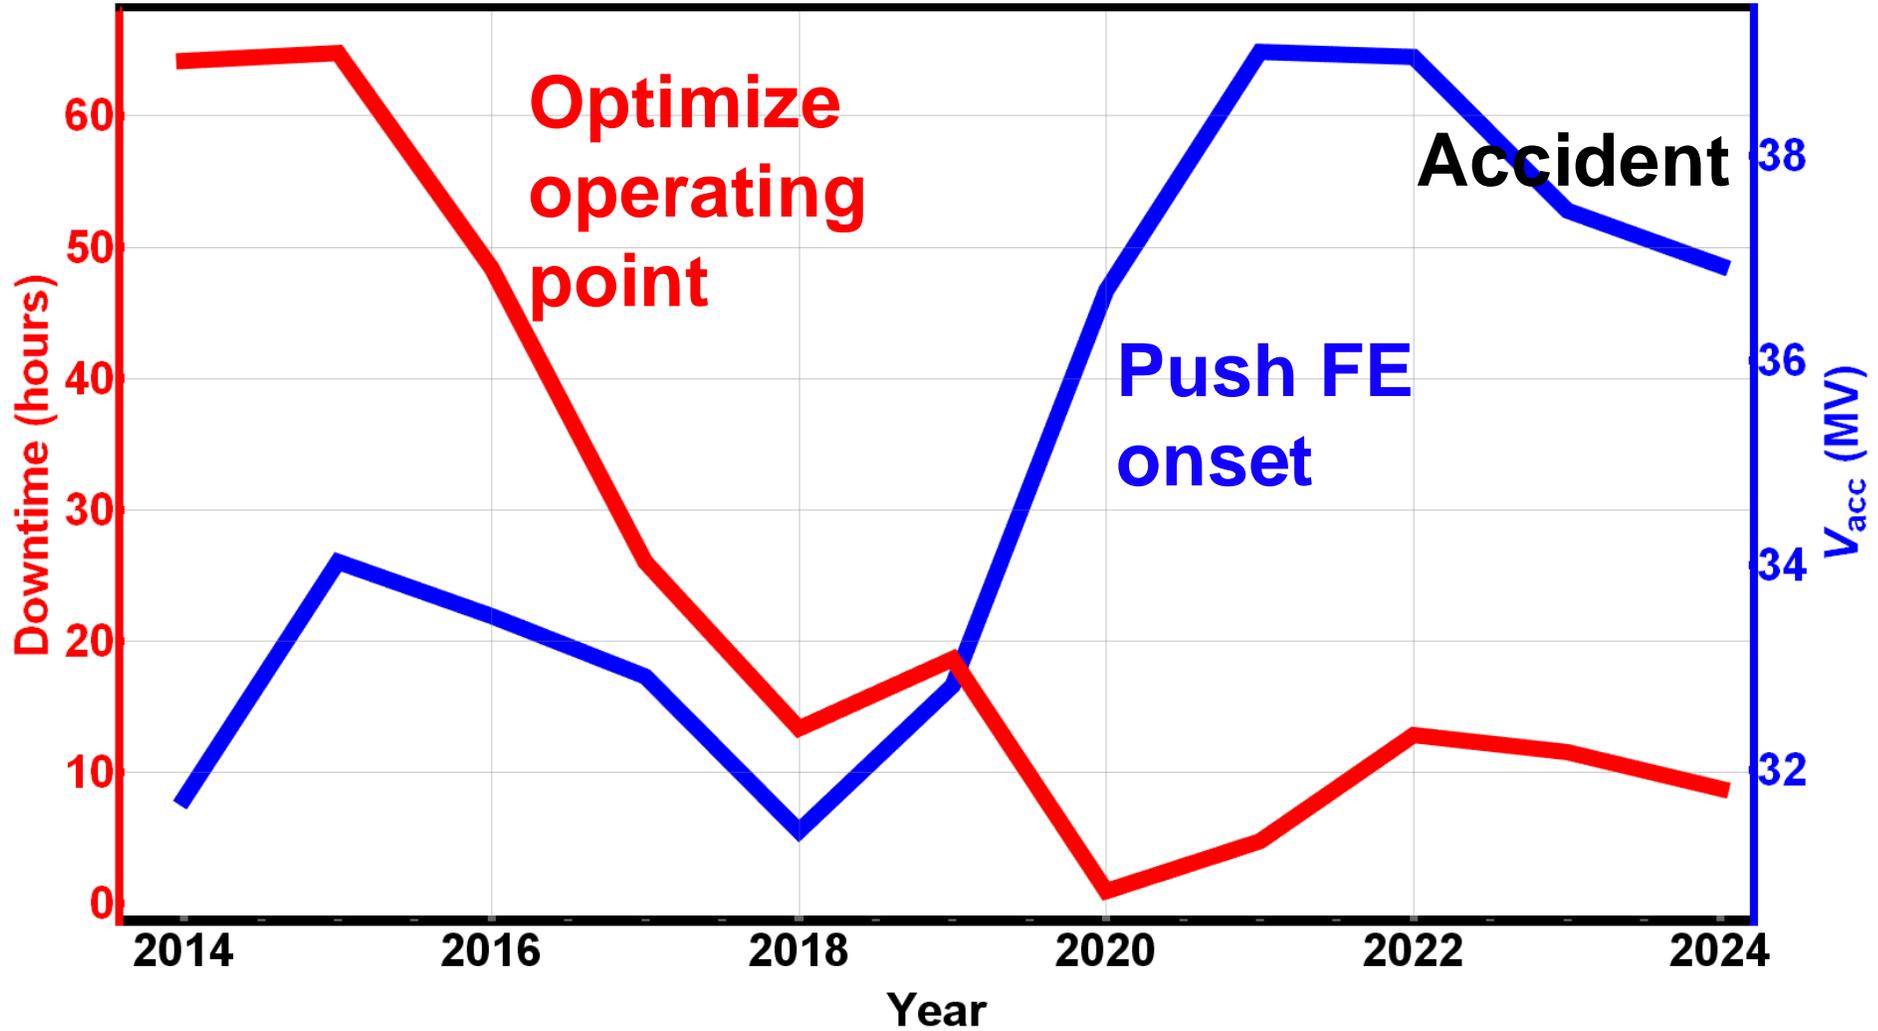
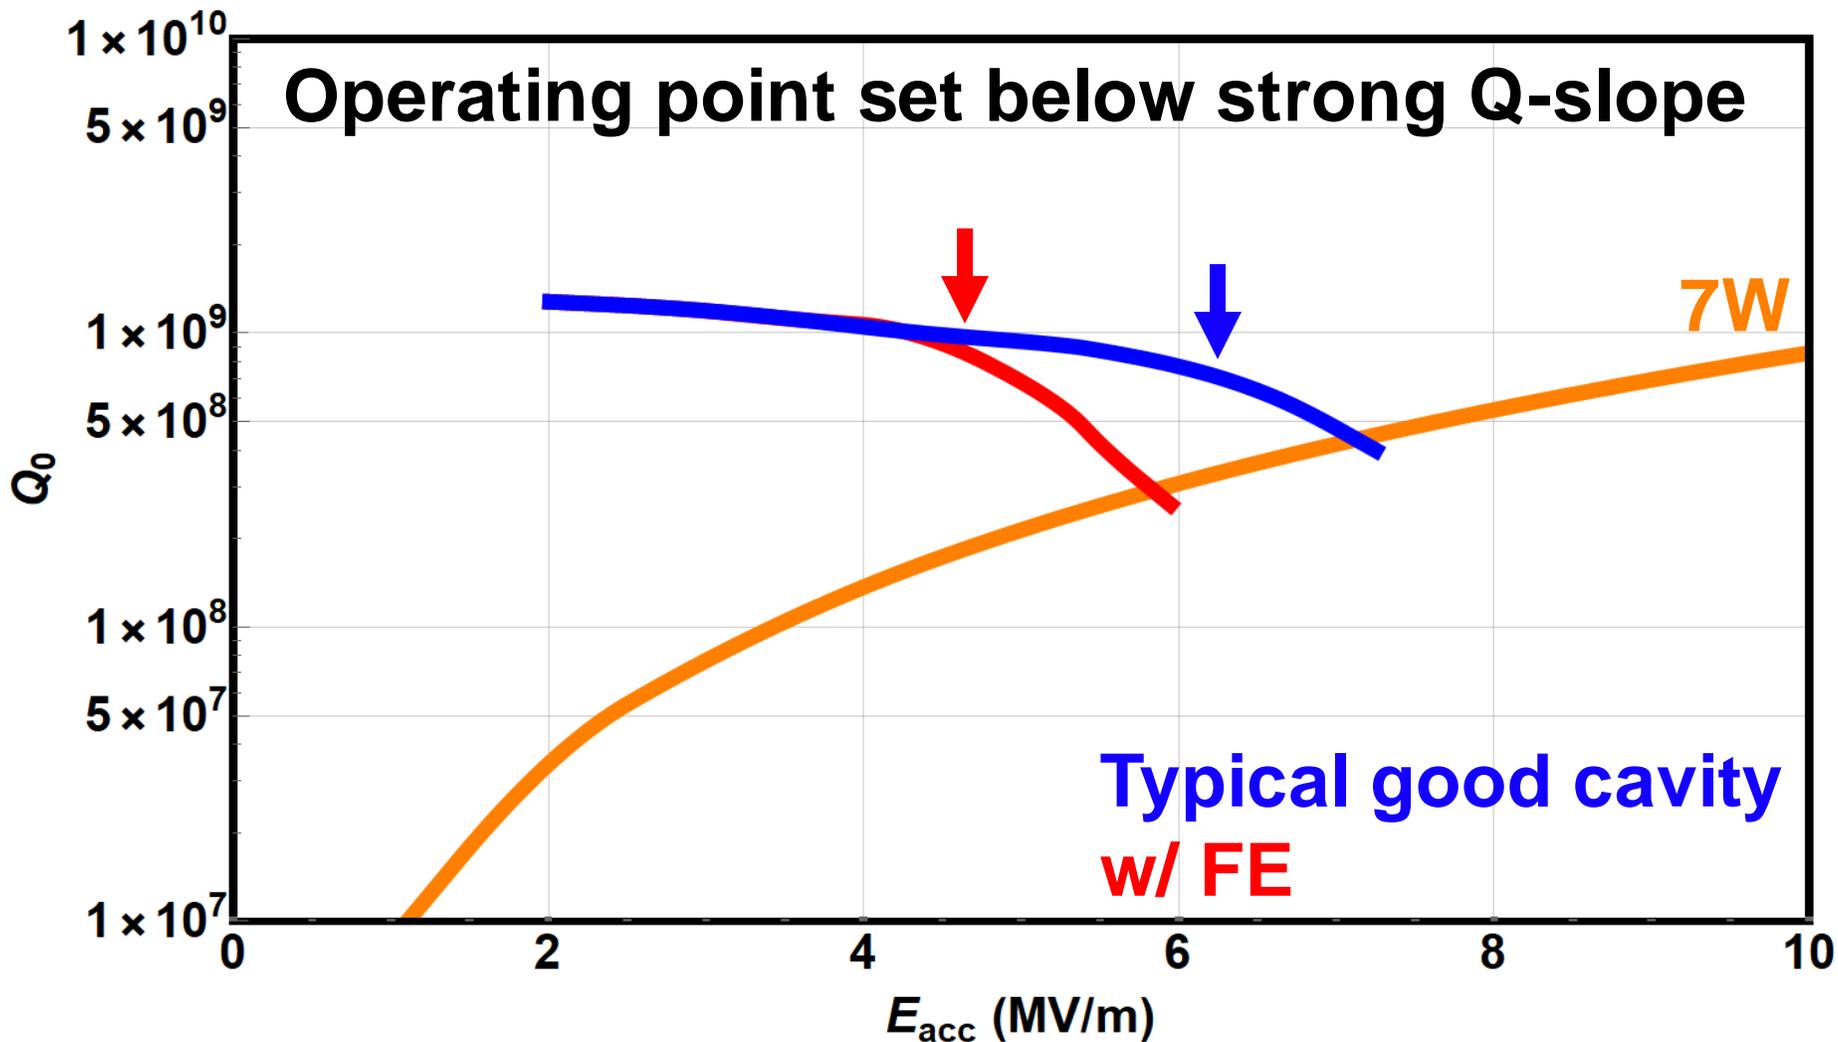
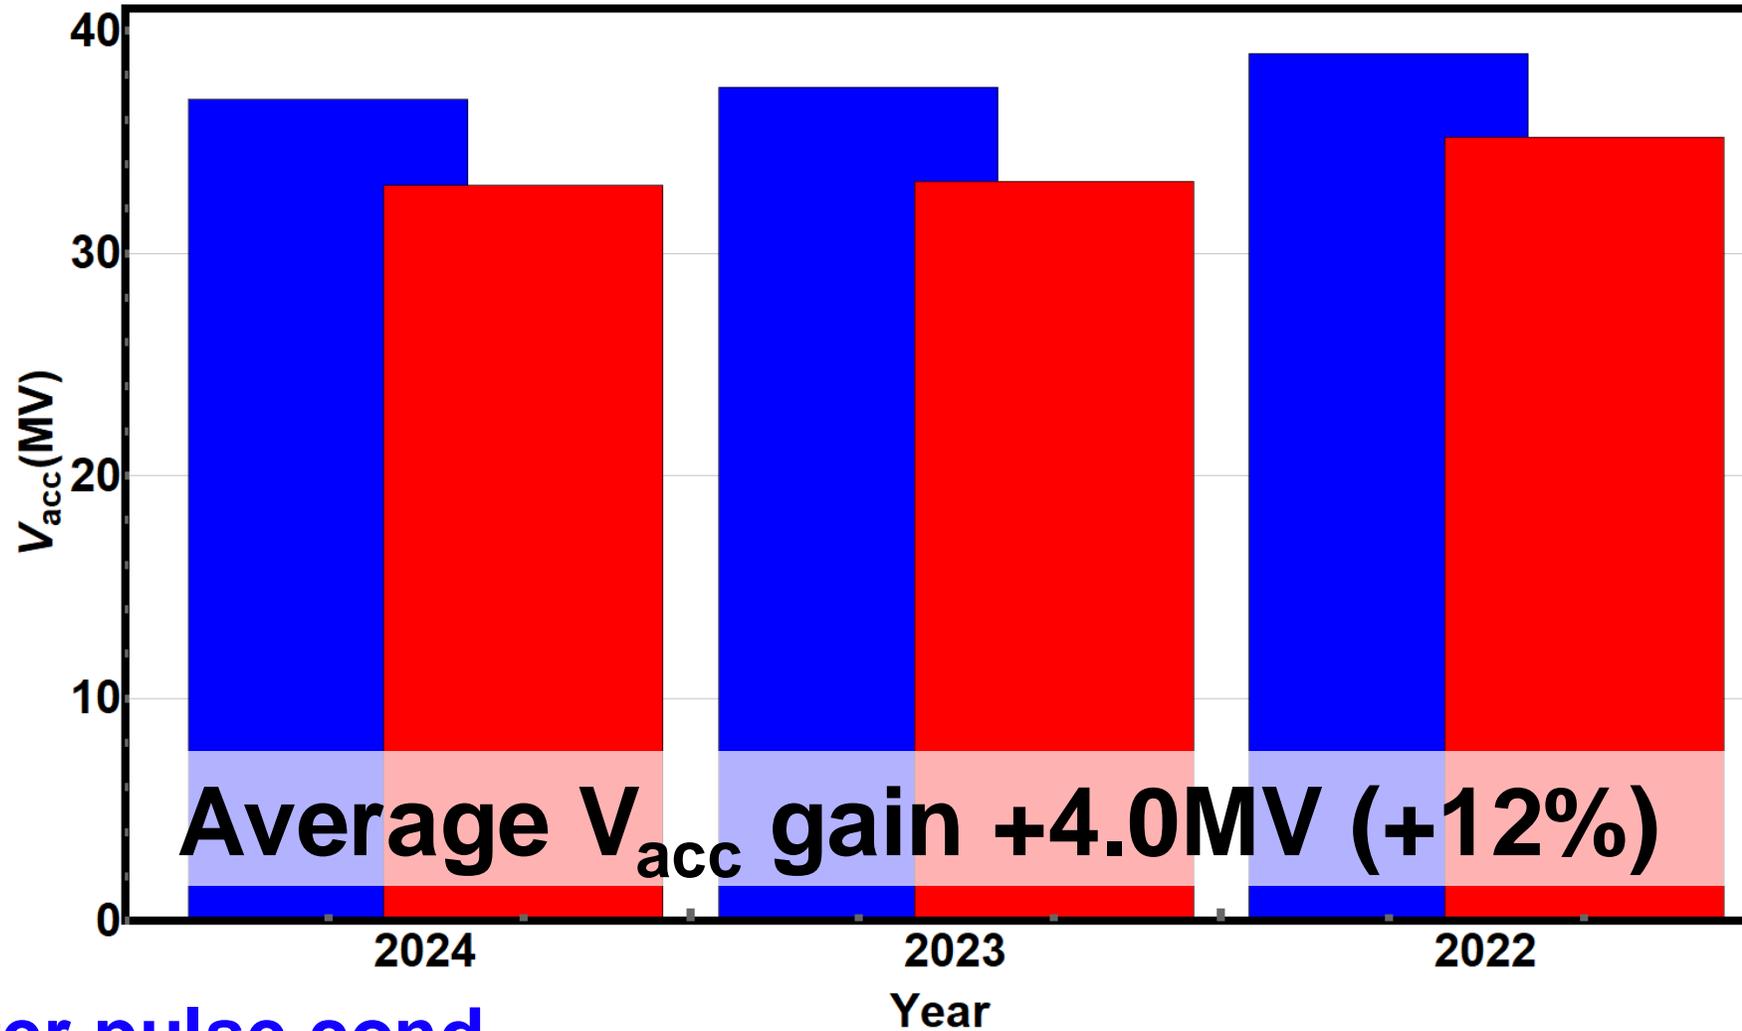
After pulse cond.
Before pulse cond.

- Improvement in minutes w/ 'electronic' quench, while requires hours to days w/ 'thermal' quench or even no changes
- Effective to restore ISAC-II cavity performance

- 40~100ms pulse length, 1Hz repetition rate, up to 200W P_{FWD}
- Variable coupler, slightly over coupling $\beta \sim 10$, normal cavity decay $\sim 200\text{ms}$
- Pulse to 50% higher field than the operating field
- Pursue 'electronic' quench to break through FE barriers

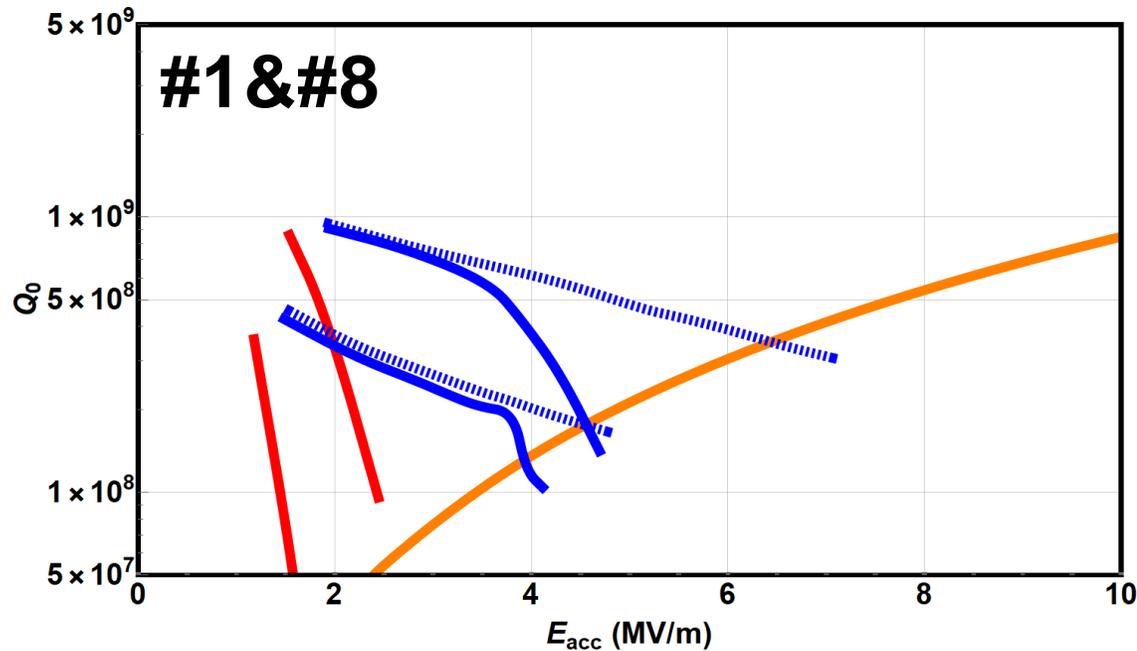
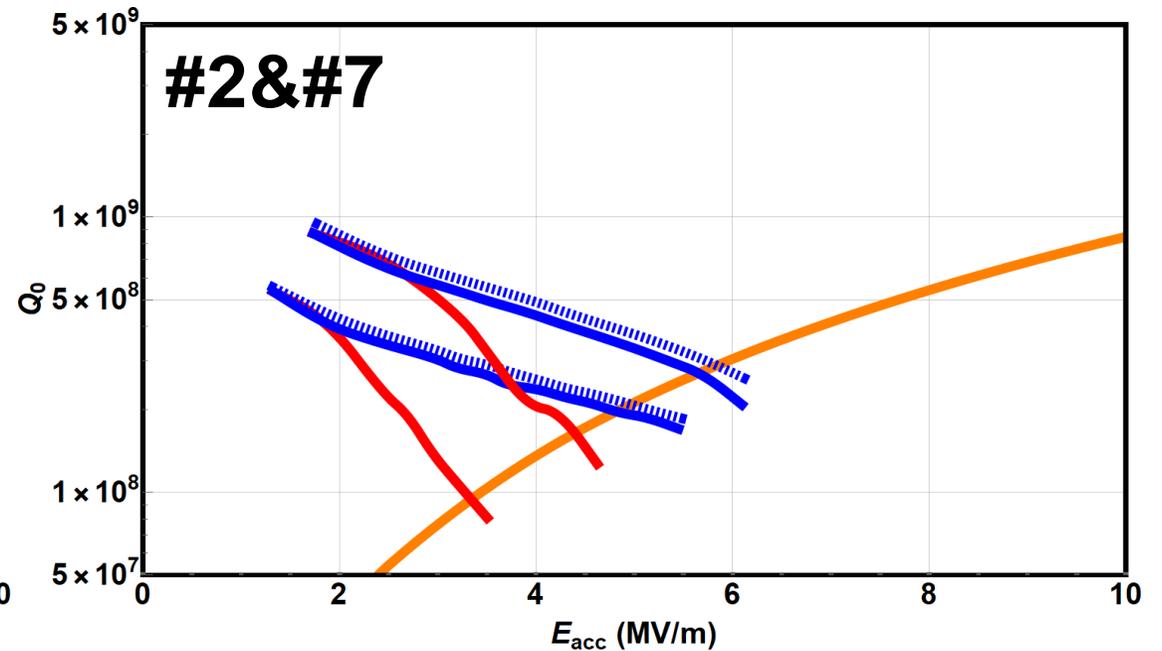
- SCC3#1 degraded after thermal cycle in shutdown
- Neighbors #2 restored after pulse conditioning
- May related to actuation of isolation valves
